SLOPE STABILITY MONITORING

Location: US Route 2, MN

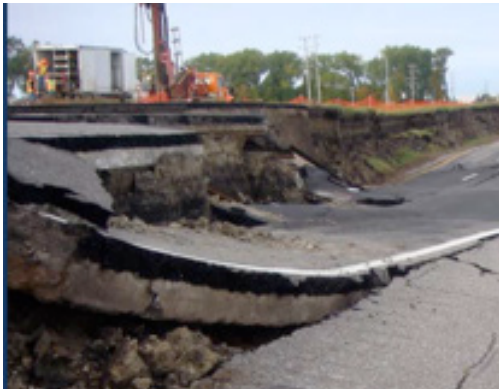
FIGURE 1

Global view of the progressive slide east of Crookston, MN.

days later, a large progressive landslide occurred, dropping a 500-foot section of US 2 down 10 feet. The slide continued over several days. The monitoring provided by ShapeArray, helped engineers ensure that no members of the public were hurt during the sliding event.

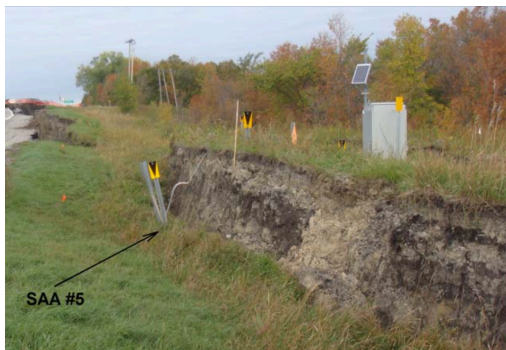
FIGURE 2

Location of ShapeArray 5 next to data acquisition system and escarpment.

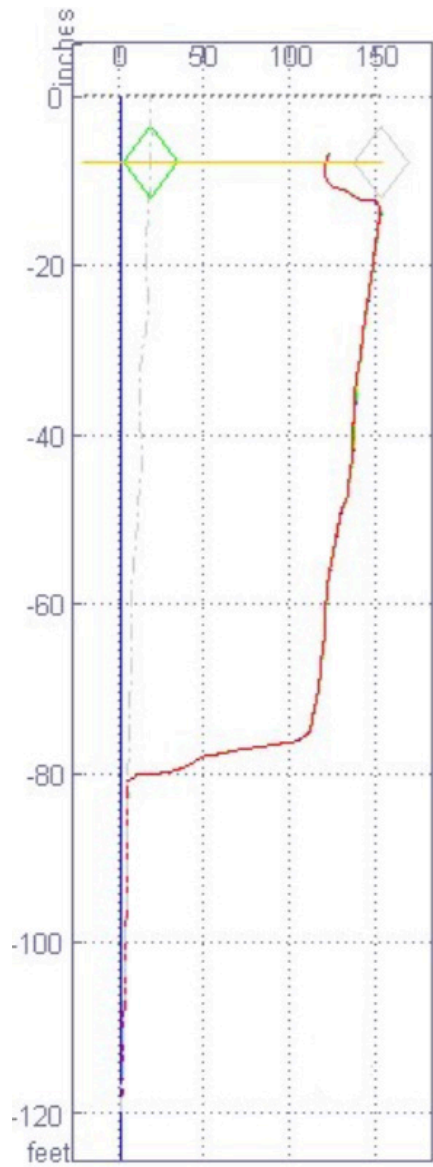
FIGURE 3

Absolute deformations measured for ShapeArray

5.

Soon after installation, ShapeArray data revealed that soil movements at the Crookston East site were deeper than anticipated. With this new data, experts determined that the slope was no longer creeping, but rather a major failure was occurring. The MnDOT closed the west-bound lanes of US 2 and detoured traffic north of the city on Monday, Sept. 15, 2008. Ten

ShapeArray survived unprecedented deformation during and after the event. The instruments continued to provide engineers with useful data until the slide forced the casing to move from their vertical down-hole position to a horizontal one. The system remains in place and provides valuable data to the MnDOT.
