MONITORING DEFORMATION BEHAVIOUR CAUSED BY ALKALI-AGGREGATE REACTION

Location: Mactaquac Dam, Keswick Ridge, New Brunswick

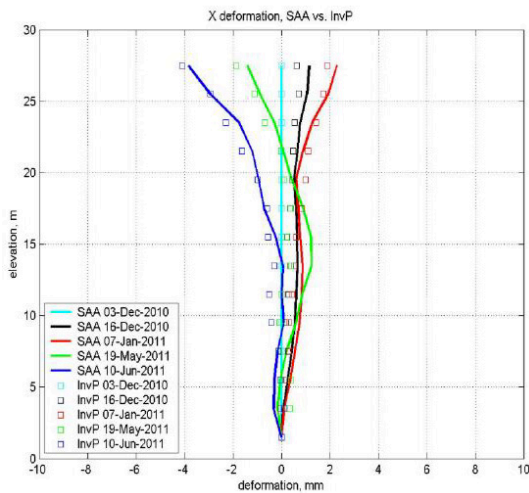
FIGURE 2
Comparison of the X data from the SAA and Inverted Pendulum.

Data showed good agreement between ShapeArray and the inverted pendulum. ShapeArray is a valuable tool in both automating long-term deformation readings and avoiding the need for precision drilling required in inverted pendulum installations.
